INDOOR AIR QUALITY ASSESSMENT

**Springfield State Office Building
436 Dwight Street
Springfield, Massachusetts**

Prepared by:
Massachusetts Department of Public Health
Bureau of Environmental Health Assessment
January, 2002

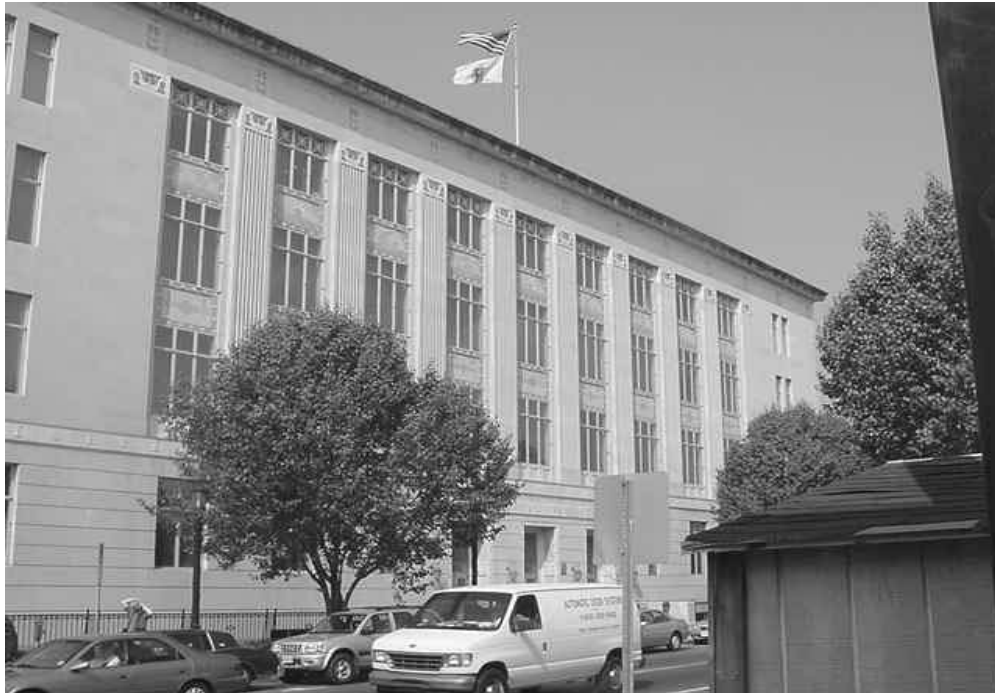
Picture 1

The SSOB is a four-story, stone and cement building constructed in 1937 (see Picture 1) as a post office. The building was renovated in the 1970s and converted into a multi-agency state office building. Each floor contains various offices of Massachusetts government agencies, including the Governor's Office, the Attorney Generals Office, the Secretary of State's Office, MA Commission Against Discrimination as well as offices of the Departments of Environmental Protection, Revenue, Industrial Accidents, Mental Retardation and the Division of Capital Assets Management. Windows are not openable.

Springfield State Office Building
